Manhole Inspection Summary

Manhole # S31K1_013MH

Location Address: **2683 Seamon Avenue**

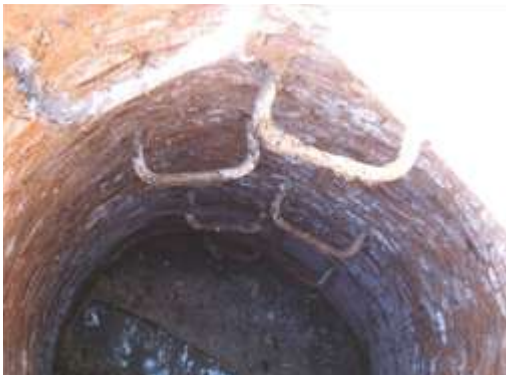
Steps Count: **7** Missing: **0** ☒ **Corroded**

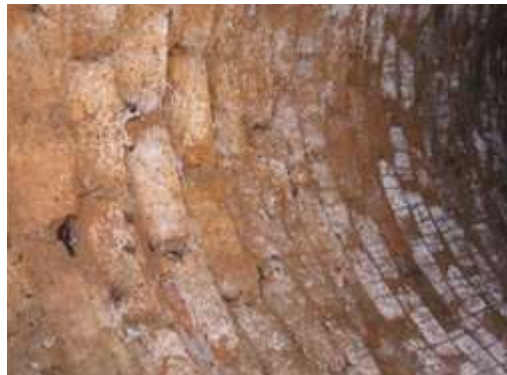
Defect 2

Infiltration: ☐ None ☐ Joint ☐ Cracks ☐ Mortar ☐ Roots ☒ **Wall**

Infiltration

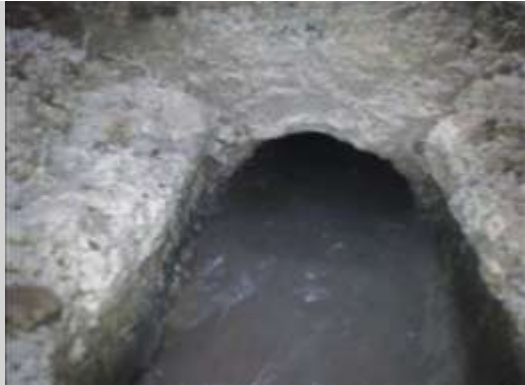
12 O'Clock Outflow

8 in. Circular Gravity Sewer
Pipe Out @ 12 O'Clock

Pipe Height: **9.6** (in.) Rod and Bar (Angled)
Pipe Material: **Clay** ☐ Pipe Lined
Invert Depth: **12.18** (ft.) Flow Characteristics: **Fast**
Deposits: ☒ None ☐ Mud ☐ Sludge ☐ Debris ☐ Grease
Silt Depth: (in.) Deposits Extent:
Infiltration: **None** Pipe Seal Cond: **Sound**

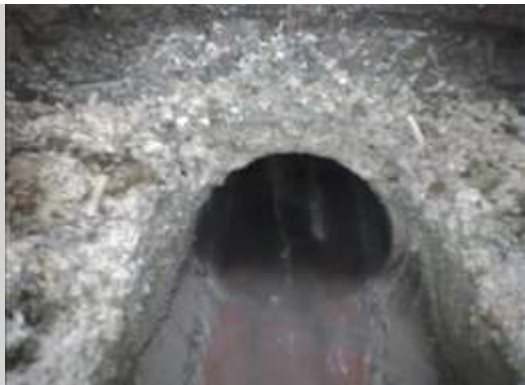
6 O'Clock Inflow

8 in. Circular Gravity Sewer
Pipe In @ 6 O'Clock

Pipe Height: **9.6** (in.) Rod and Bar (Angled)
Pipe Material: **Clay** ☐ Pipe Lined
Invert Depth: **11.87** (ft.) Flow Characteristics: **Fast**
Deposits: ☒ None ☐ Mud ☐ Sludge ☐ Debris ☐ Grease
Silt Depth: (in.) Deposits Extent:
Infiltration: **None** Pipe Seal Cond: **Sound**
